**Flood Control Project Maintenance
Levee Inspections**
LMA District Cover Sheet
Spring 2019 Levee Inspection Results

Sacramento Maintenance Yard Putah Creek

Spring 2019 Levee Inspection Results

Levee Inspection Report By Mile - Spring 2019

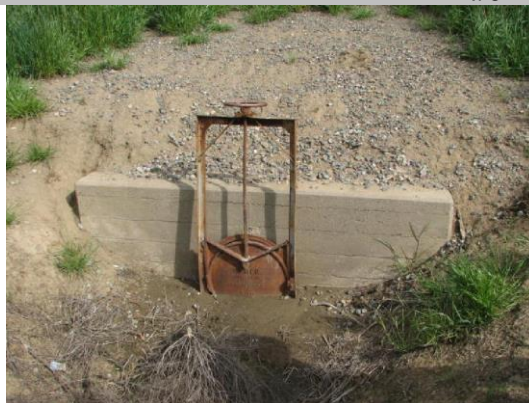
Photo 1 of 3 : UCIP_SP_2019_33408_60493.jpg

WS slide gate and headwall

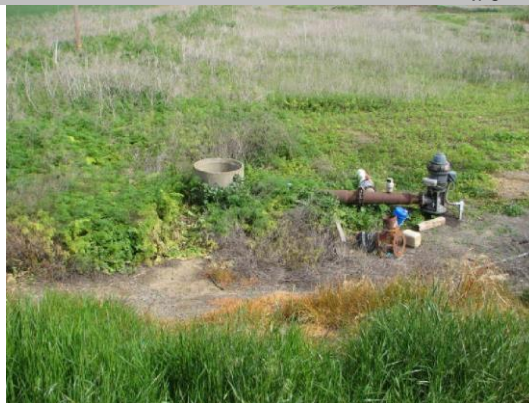
Photo 3 of 3 : UCIP_SP_2019_33408_60494.jpg

LS pump and appurtenances

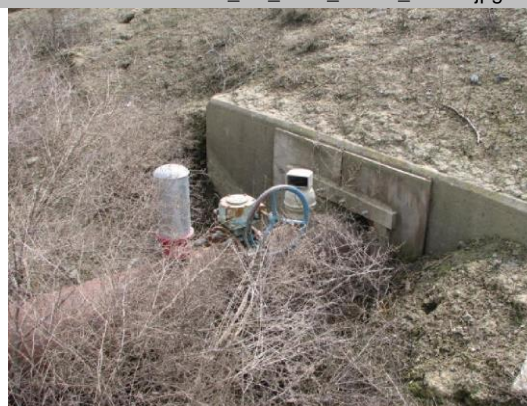
Photo 3 of 3 : UCIP_SP_2019_48122_60482.jpg

Comment Code						
Inspector Comment						
FS_ID:48122 DS_ID:489 EP_NO: 10262 Repair Type: Non-Urgent Crossing Status: Found UCIP Comments: Pump is disconnected from pipe and could cause backflow at highwater event. Can't see size of pipe sleeved through 24-inch pipe. FIELD_STRUCT_DESC: 18-inch steel irrigation pipe (field verified not 16-inch) sleeved through existing 24-inch drainage steel pipe through levee, 12.5 feet below the crown. Annular space sealed at both the waterside (WS) and landside (LS) ends. Concrete headwalls are located on both the WS and LS ends. PVC sleeved December of 2007 (unknown source). (16-inch pipe sleeved through 24-inch pipe authorized under Automatic Board Order (ABO) issued as Permit No. 10262, 1974 - Wells Fargo Bank, Trustee for S.H. Cowell Foundation) [Additional Reference(s): DWR Levee Log, March 2007. USACE Sacramento O&M Manual 119, December 1952] FS Date: 4/10/2014 2:48:00 PM

Butterfly valve at LS toe

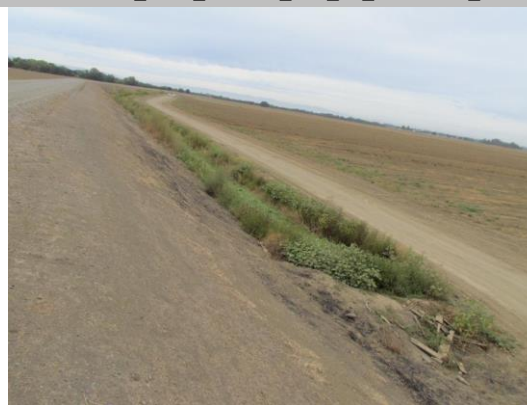
Photo 1 of 1 : SP_2019_ST0007_282_10_20190311_00004.jpg

LM Start	1.52	Rating **	M	Issue No.	10
LM End	2.67	Issue Type +	En	Location *	LS
Category	Earthen Levee			GPS Latitude/Longitude	
				Start	End
Item	Encroachments			38.515258 °	38.517376 °
				-121.655107 °	-121.676054 °
DWR ID	DWR_ST0007_01_s_2012_10				
Comment Code					
DT : Ditch					
Inspector Comment					
This agriculture ditch is owned by Dos Rios Farms

View of agriculture ditch within 10-foot of levee toe.

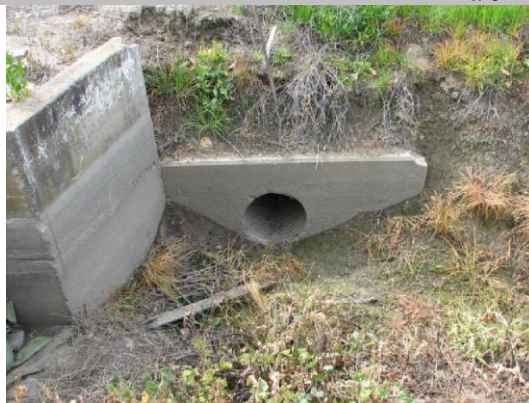
Photo 1 of 3 : UCIP_SP_2019_43033_60465.jpg

LS headwall

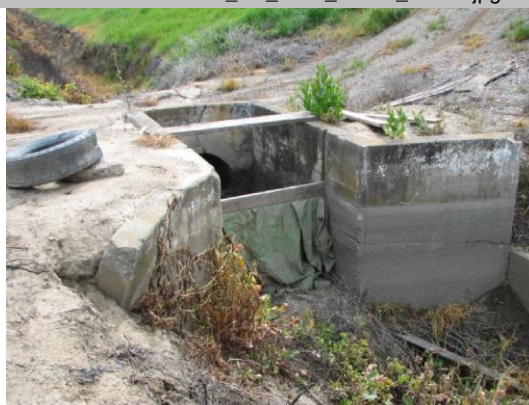
Photo 2 of 3 : UCIP_SP_2019_43033_60467.jpg

LS distribution box

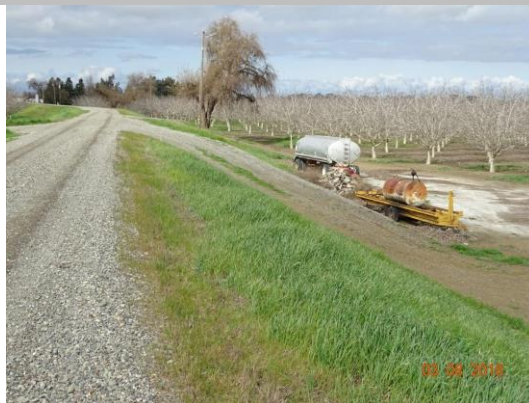
Photo 1 of 1 : SP_2019_ST0007_282_35_20190311_00008.jpg

Ag equipment and wood pile at levee toe should be removed to allow inspection and access.

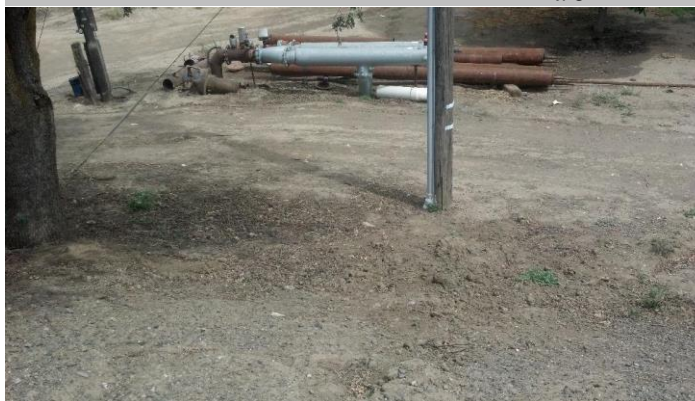
Photo 1 of 3 : UCIP_SP_2019_48013_60451.jpg

Filter Plant on LS toe

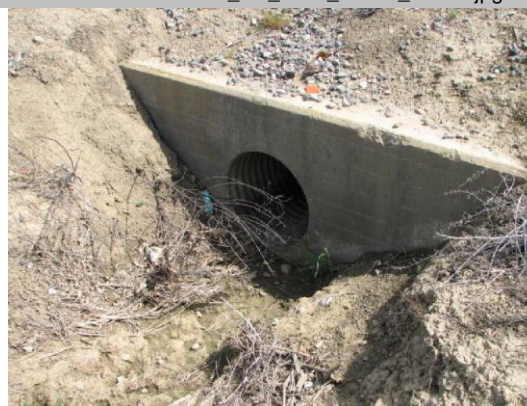
Photo 2 of 3 : UCIP_SP_2019_53863_60441.jpg

Comment Code						
Inspector Comment						
FS_ID:53863 DS_ID:496 EP_NO: 10251 Repair Type: Urgent Crossing Status: Found UCIP Comments: 4/10/2019 Major erosion through out pipe. Erosion on WS allows water to enter pipe and flood LS field. Erosion on farmers waterman valve. Field water drains into pipe and floods LS field. (J.McCabe DWR Sacramento Yard) FIELD_STRUCT_DESC: 24-inch corrugated metal drainage pipe through levee, 15 feet below the crown. Two metal cutoff walls were installed through the levee. A T-post and T-handle are located on the landside (LS) toe. The outfall structure and flap gate are located on the west side of bridge, waterside (WS). (24-inch pipe [HLM 3.87] authorized under Automatic Board Order (ABO) issued as Permit No. 10251, 1974 - F.M.C. Corp.) [Additional Reference(s): DWR Levee Log, 1981 and 2005. USACE Sacramento O&M Manual Unit 119, December 1952, (Station XX+XX)] FS Date: 4/9/2019 9:31:57 AM

LS headwall and pipe

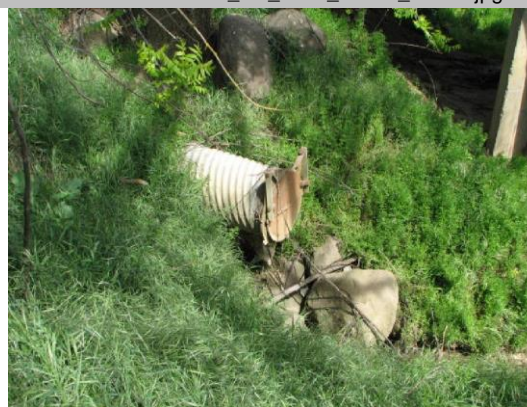
Photo 3 of 3 : UCIP_SP_2019_53863_60440.jpg

Outfall at creek with flap gate.

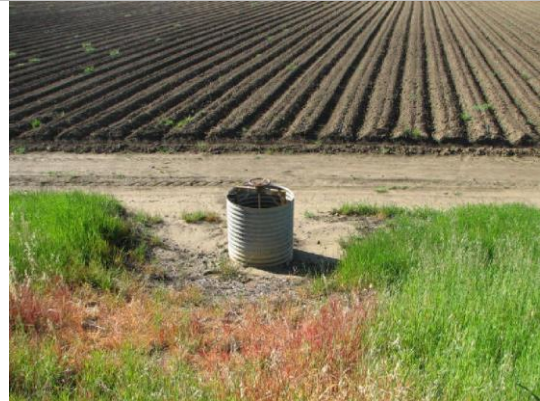
Photo 1 of 1 : UCIP_SP_2019_33379_60436.jpg

Slide gate in 36-inch Standpipe on WS toe.

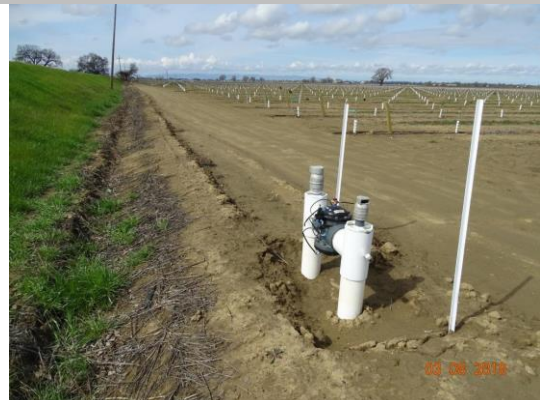
Photo 1 of 2 : SP_2019_ST0007_282_39_20190311_00009.jpg

LM Start	4.32	Rating **	M	Issue No.	39
LM End	4.80	Issue Type +	En	Location *	LS
Category	Earthen Levee			GPS Latitude/Longitude	
				Start	End
Item	Encroachments			38.518280 °	38.518041 °
				-121.704657 °	-121.713680 °
DWR ID	DWR_ST0007_01_s_2018_39				
Comment Code					
PI : Pipe					
Inspector Comment					
Newly planted orchard on LS appears to have installed a water pipe with visible risers parallel to levee approx 8 feet from toe. This pipe should be verified, and owner should contact CVFPB for direction.

Visible riser on suspected new pipeline running parallel to levee, 8 feet from toe.

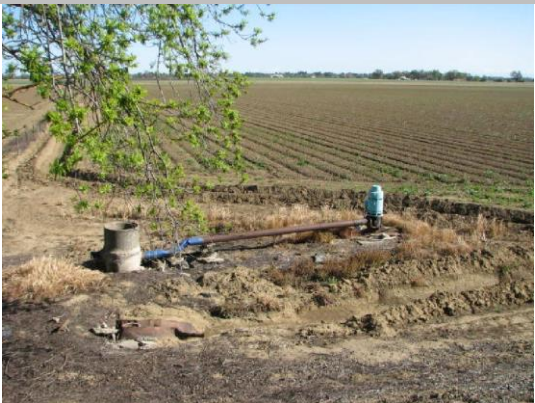
Photo 1 of 2 : UCIP_SP_2019_33370_60415.jpg

LS pump and stand pipe

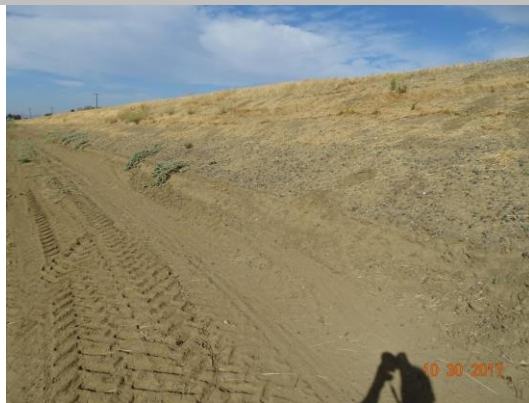
Photo 2 of 2 : SP_2019_ST0007_282_50_20190311_00012.jpg

Agricultural tilling has encroached into waterside levee toe. Activity should cease and toe should be repaired.

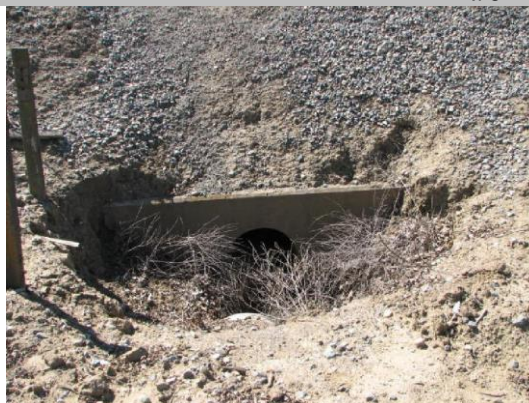
Photo 1 of 2 : UCIP_SP_2019_33368_60410.jpg

LS headwall

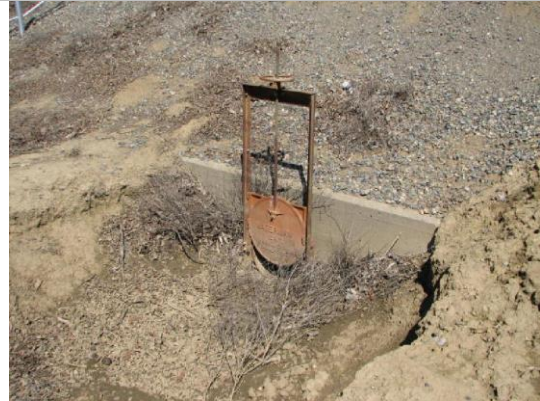
Photo 2 of 2 : UCIP_SP_2019_33368_60409.jpg

WS slide gate

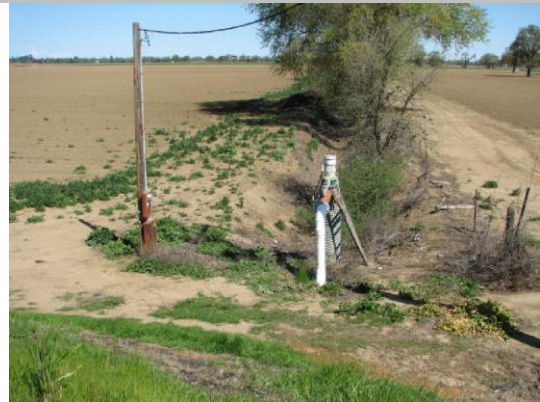
Photo 1 of 3 : UCIP_SP_2019_33367_60406.jpg

LS pump and pipe

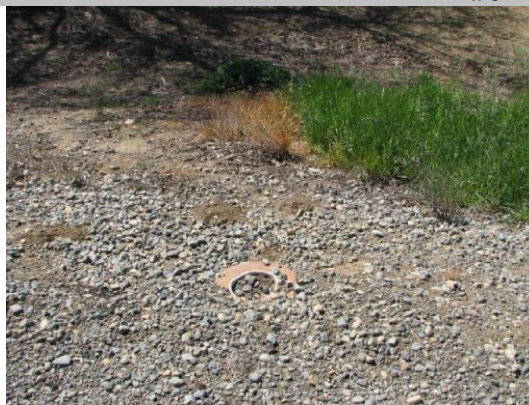
Photo 3 of 3 : UCIP_SP_2019_33367_60407.jpg

WS shoulder broken air vent

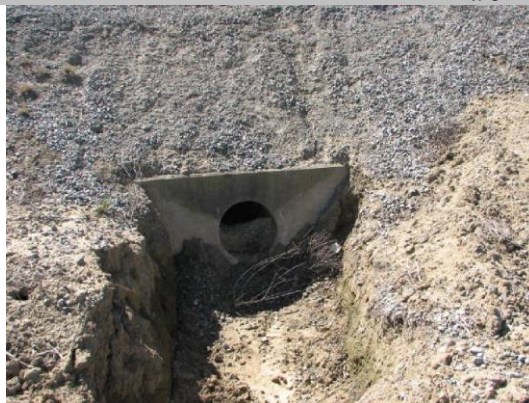
Photo 1 of 2 : UCIP_SP_2019_33364_60401.jpg

Comment Code					
Inspector Comment					
FS_ID:33364 DS_ID:503 EP_NO: 10252 Repair Type: No Action Needed Crossing Status: Found UCIP Comments: owner of pipe needs to clean out obstruction in pipe. FIELD_STRUCT_DESC: 24-inch corrugated metal drainage pipe through the levee, 12 feet below the crown. Slide gate on the waterside (WS) end. Concrete headwall on the landside (LS) end. (24-inch pipe [HLM 5.86] authorized under Automatic Board Order (ABO) issued as Permit No. 10252, 1974 - John F. Hamel). [Additional Reference(s): DWR Levee Log, 2005. USACE Sacramento O&M Manual 119, December 1952, (Station 108+00 PCT)]. FS Date: 4/10/2014 2:34:15 PM

LS headwall

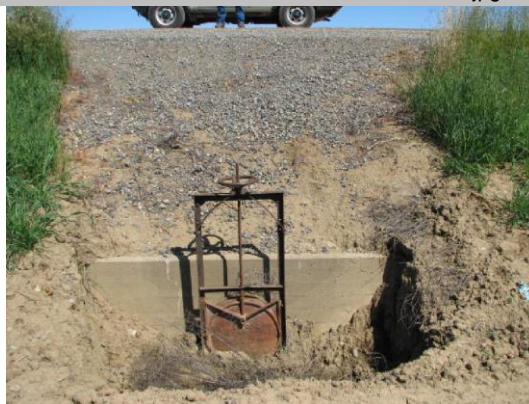
Photo 2 of 2 : UCIP_SP_2019_33364_60400.jpg

WS headwall and slidegate

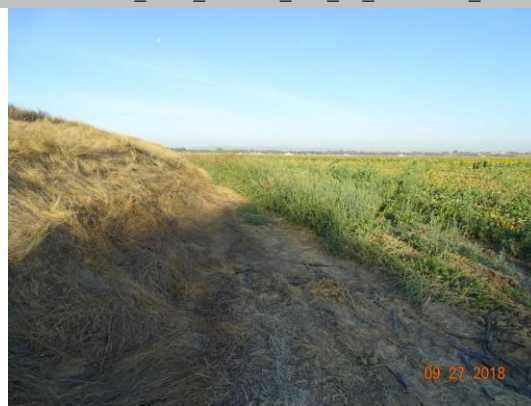
Photo 1 of 3 : SP_2019_ST0007_282_53_20190311_00013.jpg

LM Start	5.84	Rating **	A/W	Issue No.	53
LM End	5.86	Issue Type +	En	Location *	LS
Category	Earthen Levee			GPS Latitude/Longitude	
				Start	End
Item	Encroachments			38.518475 °	38.518478 °
				-121.732822 °	-121.733200 °
DWR ID	DWR_ST0007_01_f_2017_53				
Comment Code					
AT : Agricultural tilling					
Inspector Comment					
Adjacent ag field is currently planted, but not along encroached area. Condition should be monitored.

View looking upstream. Vegetation has encroached on the toe that is covering past evidence of agricultural tilling (September 2018).

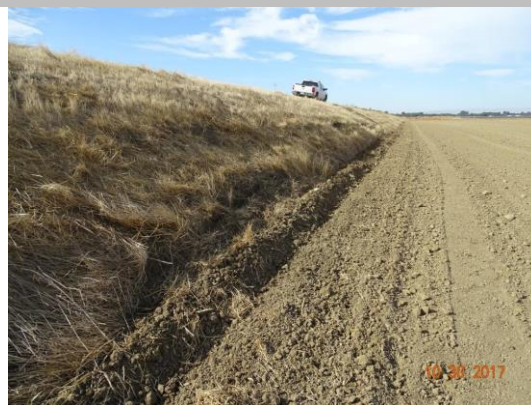
Photo 2 of 3 : SP_2019_ST0007_282_53_20190311_00014.jpg

Agricultural tilling has encroached into landside levee toe. Activity should cease and toe should be repaired.

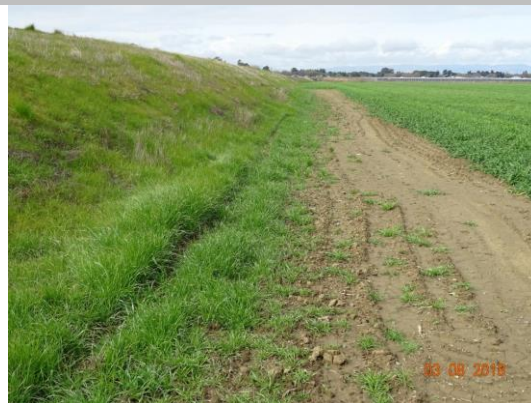
Photo 3 of 3 : SP_2019_ST0007_282_53_20190311_00015.jpg

Fleed not currently planted in area were tilling previously encroached on levee toe. Continue to monitor. Toe should be repaired.

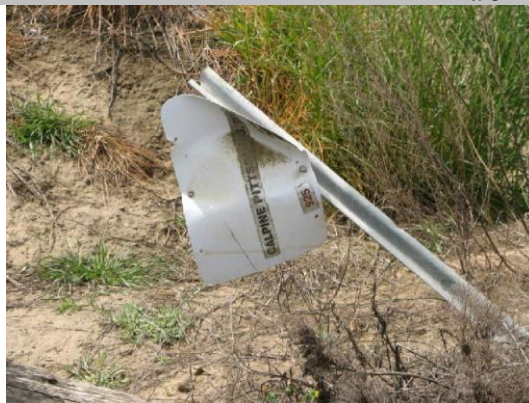
Photo 1 of 2 : UCIP_SP_2019_33347_60366.jpg

Comment Code					
Inspector Comment					
FS_ID:33347 DS_ID:506 EP_NO: 10820 Repair Type: Non-Urgent Crossing Status: Indicator Found UCIP Comments: Sign on LS bent over and broken. New signs need to be installed locating pipe that indicate a gas line crossing. The broken or missing signs do not indicate gasline, only owner info. Owner is Calpine NRG Scott Vickers 707-249-9211. Supervisor will call phone number and ask for new signs to be installed. FIELD_STRUCT_DESC: 4-inch coated steel gas line through the levee, 2 feet below the crown. (Permit No. 10820, 1975 - Dow Chemical). [Additional Reference(s): DWR Levee Log, 2005]. FS Date: 4/10/2014 2:28:50 PM

LS sign post with damaged sign.

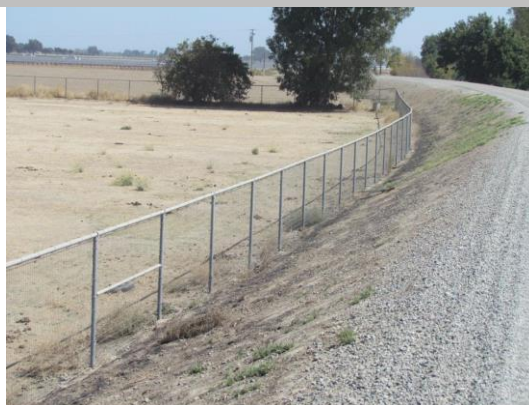
Photo 2 of 2 : SP_2019_ST0007_282_5_20190311_00003.jpg

Levee mile 6.63-6.71 landside levee toe.

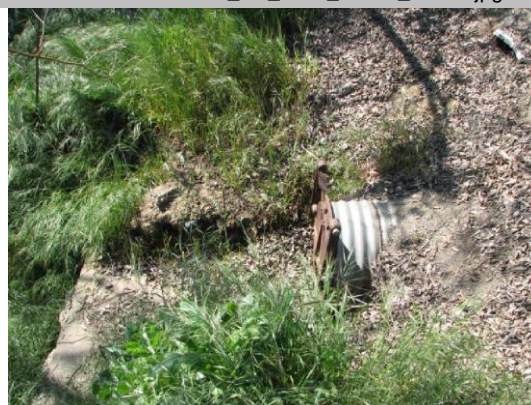
Photo 1 of 3 : UCIP_SP_2019_33343_60357.jpg

WS flap gate

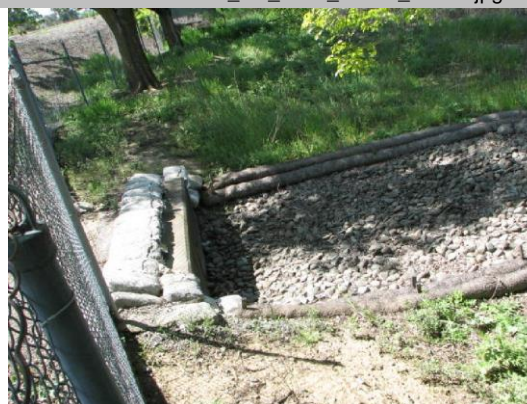
Photo 3 of 3 : UCIP_SP_2019_33343_60358.jpg

LS headwall

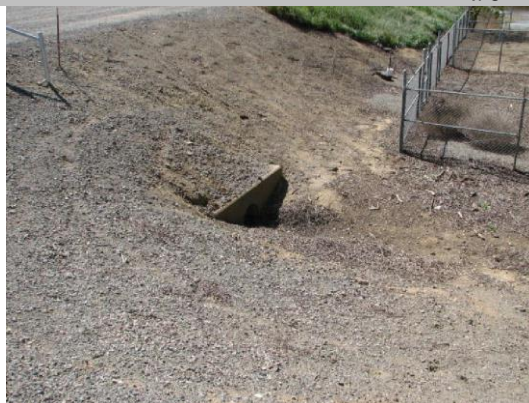
Photo 1 of 2 : UCIP_SP_2019_42952_60353.jpg

LS Headwall

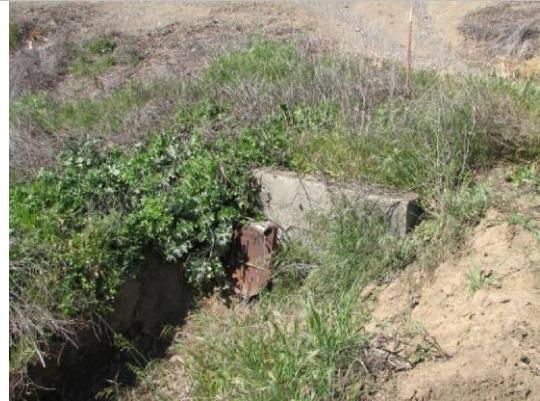
Photo 2 of 2 : UCIP_SP_2019_42952_60352.jpg

WS Flapgate

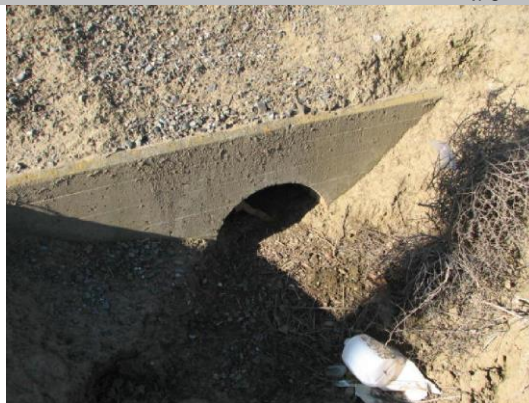
Photo 2 of 2 : UCIP_SP_2019_41353_60344.jpg

LS headwall showing pipe partially blocked with soil.

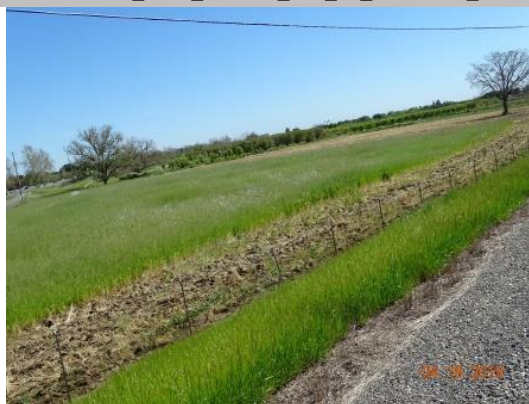
Photo 1 of 1 : SP_2019_ST0007_282_42_20190418_00074.jpg

View looking downstream at barbed wire fence located within the landside easment (Spring 2019).

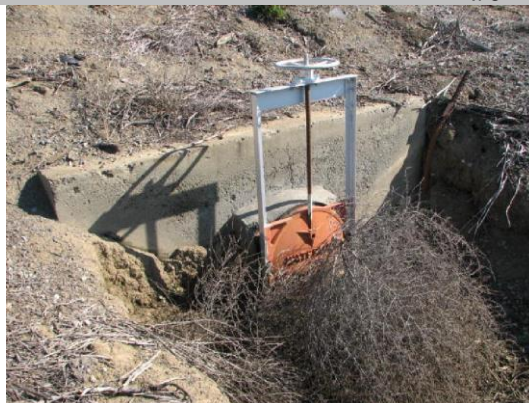
Photo 1 of 2 : UCIP_SP_2019_33333_60342.jpg

WS headwall and slide gate

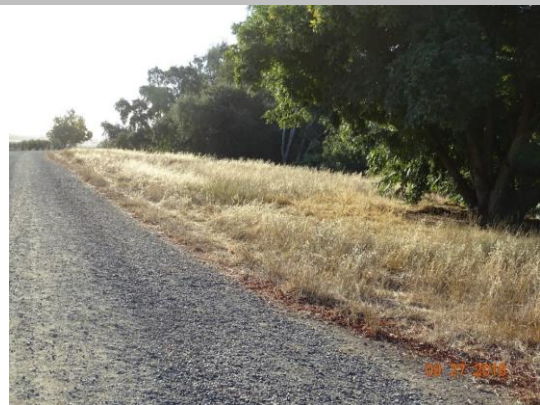
Photo 1 of 1 : SP_2019_ST0007_282_29_20190311_00006.jpg

View looking downstream at thick vegetation up to the crown (September 2018).

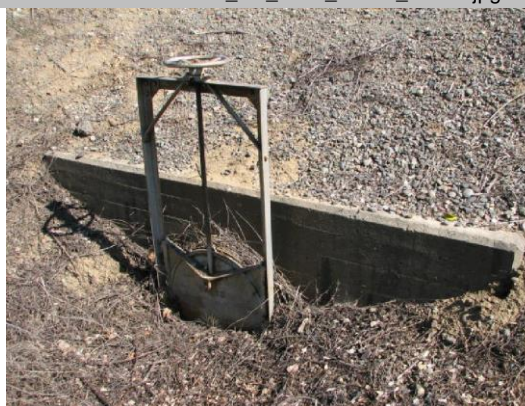
Photo 3 of 3 : UCIP_SP_2019_33328_60328.jpg

WS slide gate showing some blockage with soil.

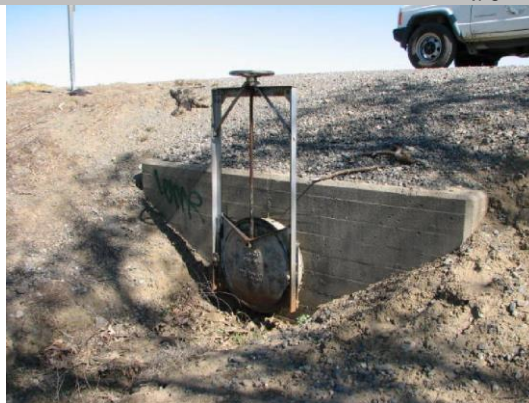
Photo 1 of 2 : UCIP_SP_2019_33327_60326.jpg

WS headwall and slidegate

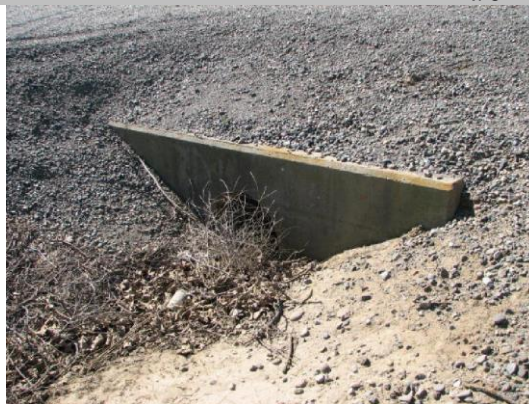
Photo 2 of 2 : UCIP_SP_2019_33327_60325.jpg

LS headwall showing partial blockage

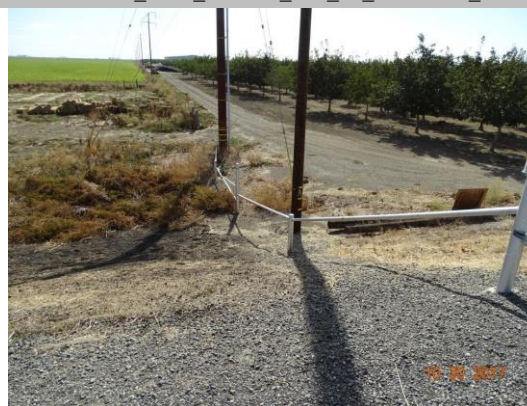
Photo 4 of 4 : SP_2019_ST0007_283_29_20190311_00009.jpg

Another landside view. No CVFPB Permit for this gate.

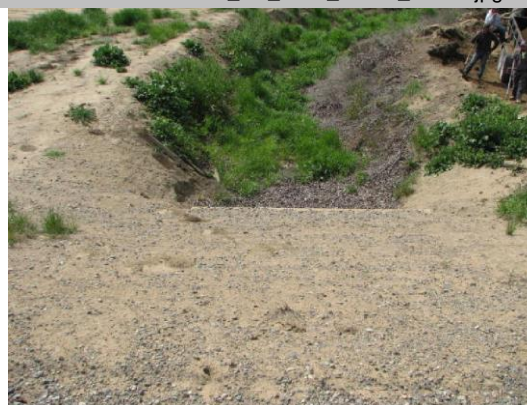
Photo 1 of 3 : UCIP_SP_2019_33407_60489.jpg

L/S inlet

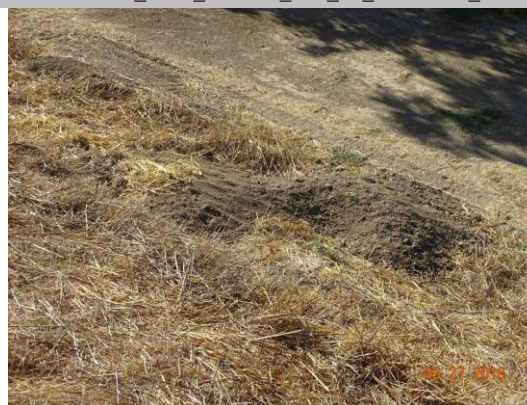
Photo 2 of 3 : SP_2019_ST0007_283_32_20190311_00011.jpg

View looking down slope at one of the animal holes on the levee slope with fresh dirt in front of the hole (September 2018).

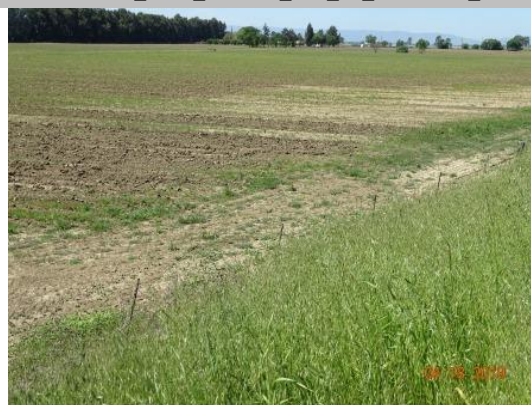
Photo 1 of 1 : SP_2019_ST0007_283_37_20190418_00063.jpg

View looking upstream at barbed wire fence at the landside toe (Spring 2019).

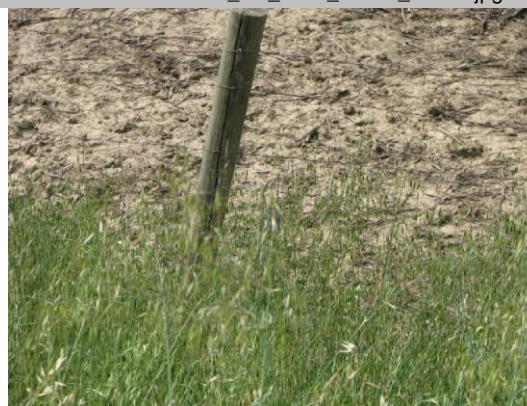
Photo 3 of 3 : UCIP_SP_2019_33400_60473.jpg

steel sign marker at LS toe with no sign

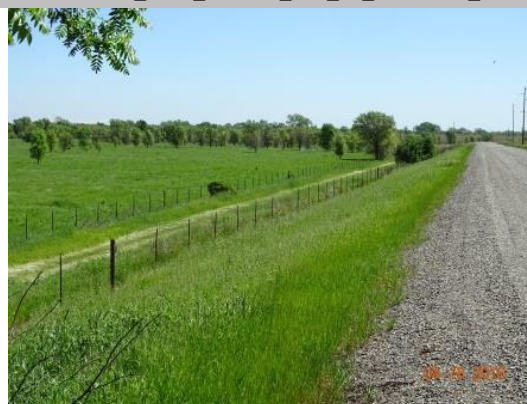
Photo 1 of 1 : SP_2019_ST0007_283_30_20190418_00060.jpg

View looking downstream at barbed wire fence at the bottom of the waterside slope (Spring 2019).

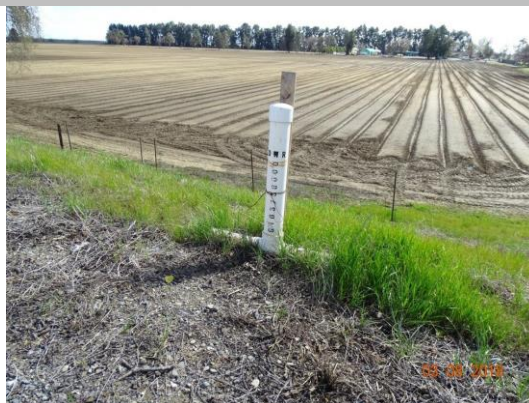
Photo 1 of 1 : SP_2019_ST0007_283_9_20190311_00002.jpg

Rodent bait station at LM 2.09.

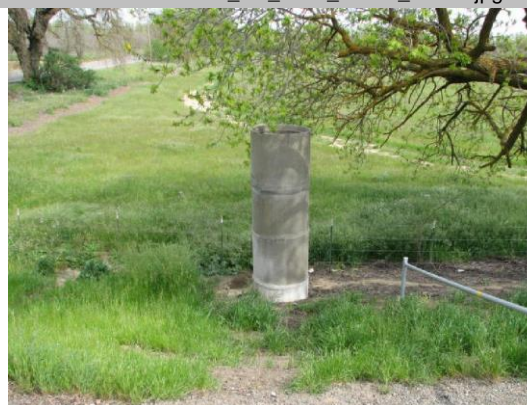
Photo 2 of 3 : UCIP_SP_2019_41072_60471.jpg

36-inch standpipe WS toe

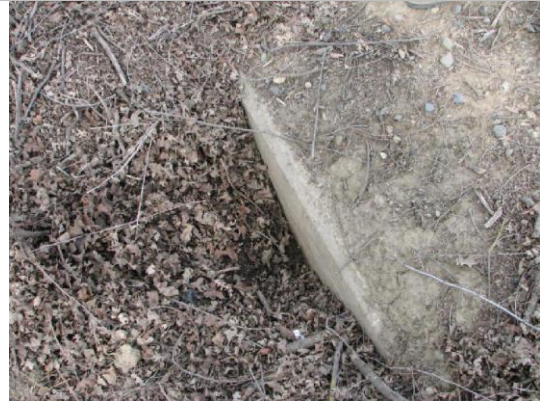
Photo 3 of 3 : UCIP_SP_2019_41072_60470.jpg

LS headwall.

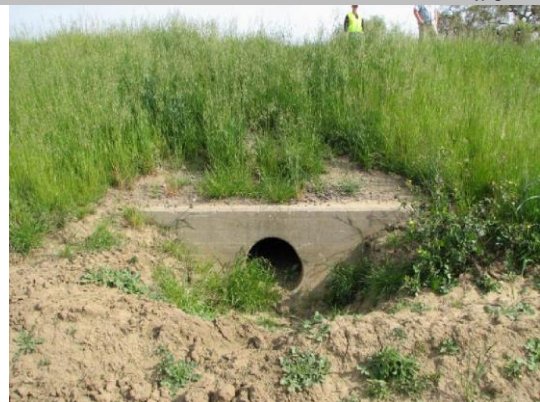
Photo 1 of 2 : UCIP_SP_2019_33395_60460.jpg

LS headwall

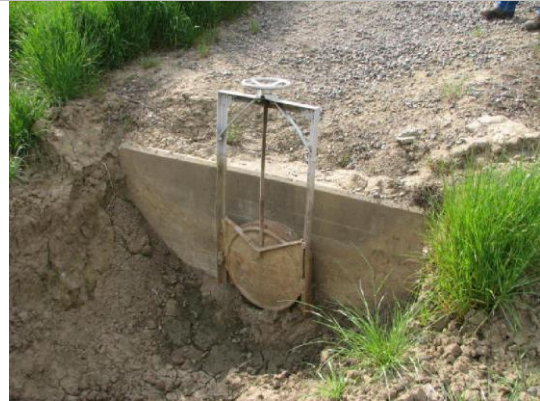
Photo 2 of 2 : UCIP_SP_2019_33395_60459.jpg

WS headwall and slidegate

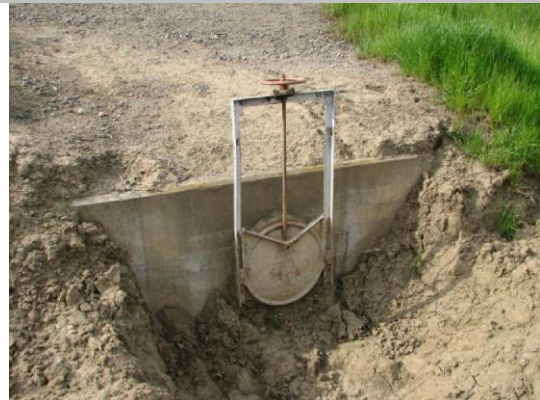
Photo 1 of 2 : UCIP_SP_2019_33393_60456.jpg

WS headwall and slide gate

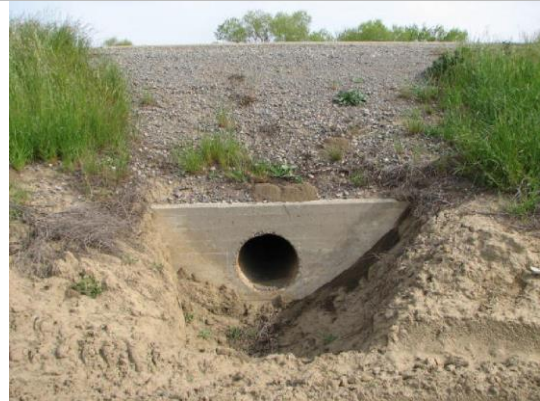
Photo 2 of 2 : UCIP_SP_2019_33393_60455.jpg

LS headwall and pipe

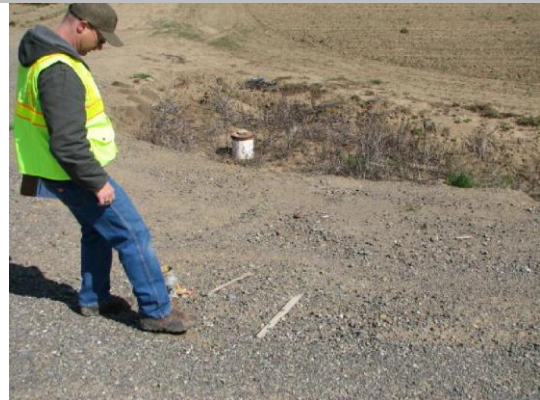
Photo 1 of 1 : UCIP_SP_2019_33392_60454.jpg

WS shoulder showing air vent with no sign and 18-inch standpipe at WS toe.

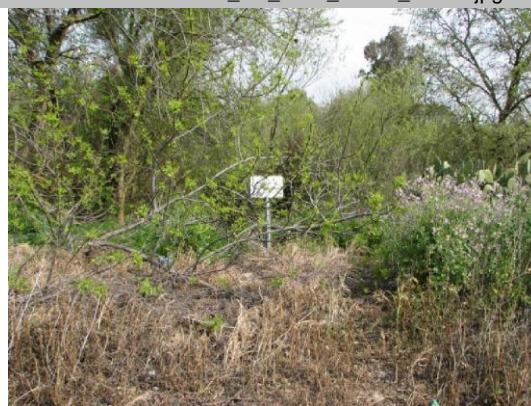
Photo 1 of 2 : UCIP_SP_2019_33377_60433.jpg

WS marker 320 feet north of levee at stream bank.

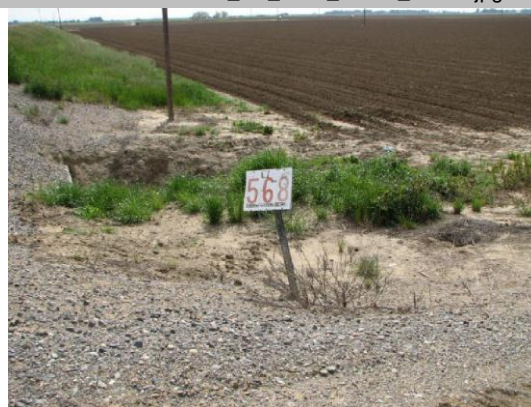
Photo 2 of 2 : UCIP_SP_2019_33377_60432.jpg

LS marker on east side of access ramp.

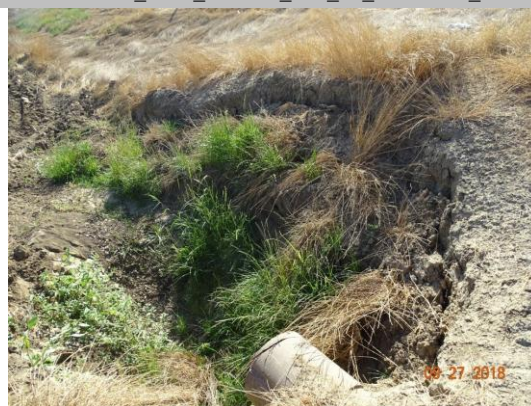
Photo 1 of 1 : SP_2019_ST0007_283_33_20190311_00013.jpg

View of erosion on the levee slope appears to be due to water from the pipe and trench (September 2018).

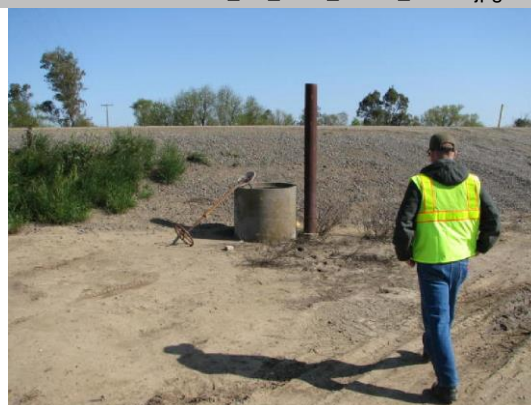
Photo 1 of 3 : UCIP_SP_2019_33375_60427.jpg

LS 36-inch standpipe

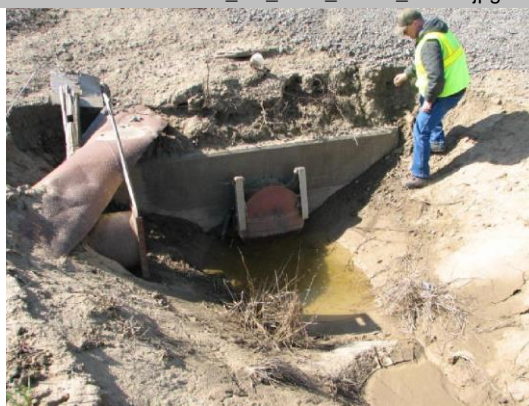
Photo 2 of 3 : UCIP_SP_2019_33375_60429.jpg

WS headwall and flapgate.

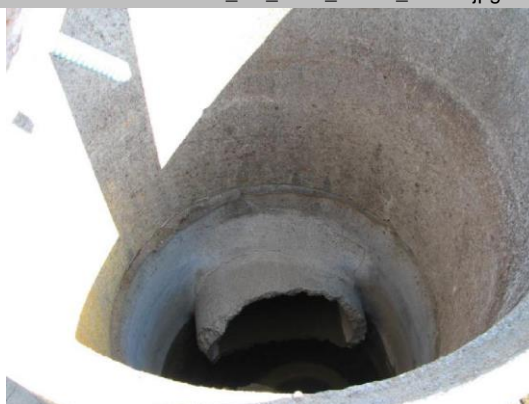
Photo 3 of 3 : UCIP_SP_2019_33375_60428.jpg

LS looking down standpipe at CC pipe

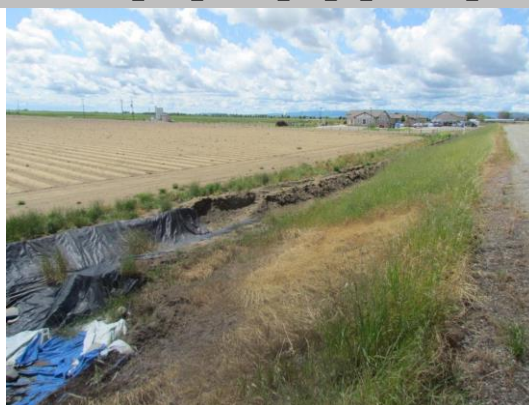
Photo 1 of 1 : SP_2019_ST0007_283_34_20190311_00014.jpg

Landside levee toe levee mile 4.97-5.00 looking upstream at unauthorized agriculture ditch placed within the easement. No permit for this encroachment was found.

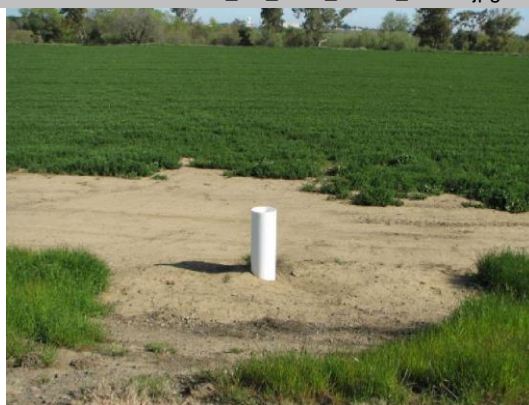
Photo 1 of 1 : UCIP_SP_2019_41074_60419.jpg

15-inch standpipe at location where may run through 24-inch SD.

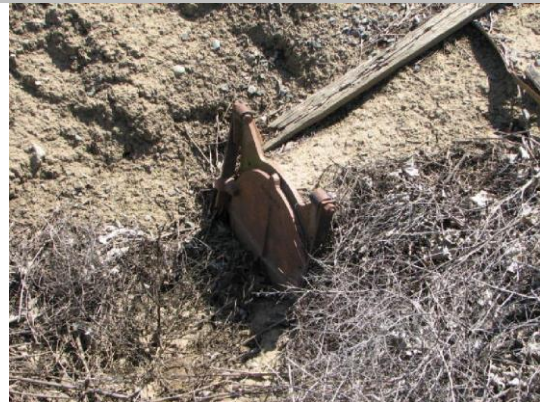
Photo 1 of 2 : UCIP_SP_2019_42953_60397.jpg

WS Flapgate blocked by sedimentation

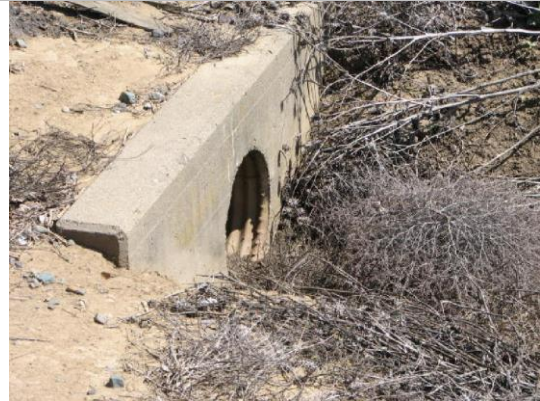
Photo 2 of 2 : UCIP_SP_2019_42953_60396.jpg

LS headwall

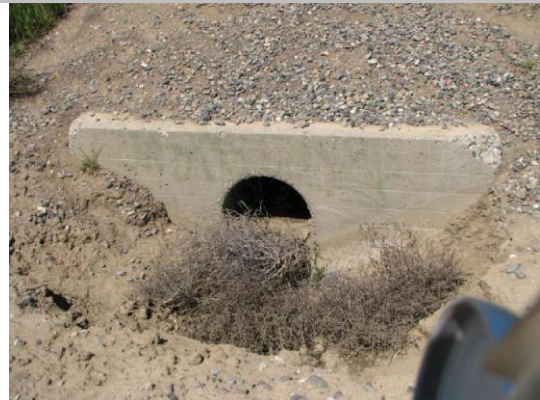
Photo 1 of 2 : UCIP_SP_2019_33353_60380.jpg

LS headwall and pipe showing sediment buildup.

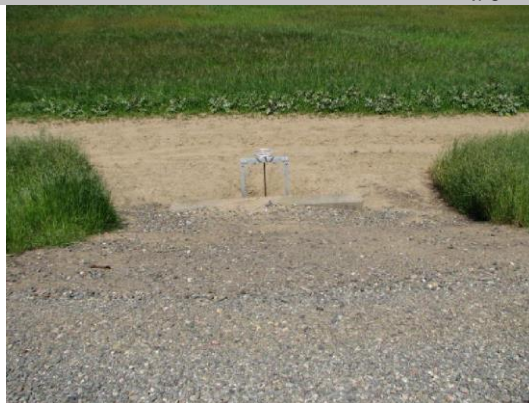
Photo 2 of 2 : UCIP_SP_2019_33353_60379.jpg

WS slide gate

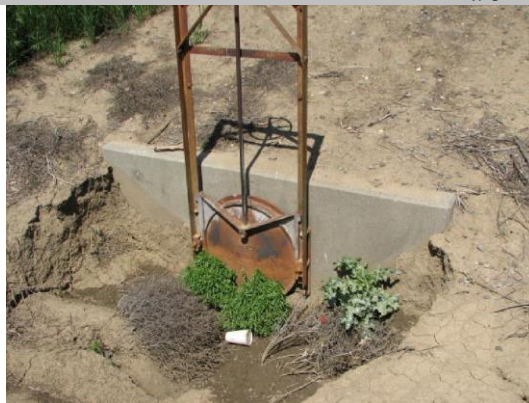
Photo 1 of 2 : UCIP_SP_2019_53864_60374.jpg

LS slide gate

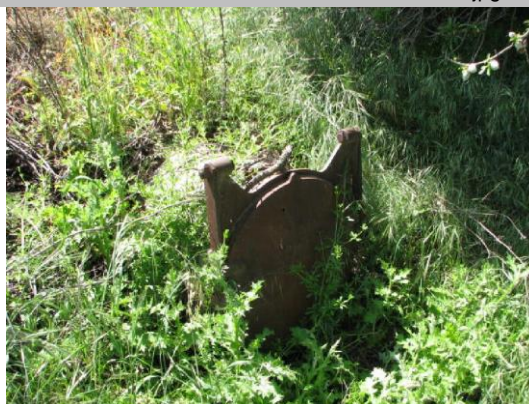
Photo 2 of 2 : UCIP_SP_2019_53864_60373.jpg

WS flap gate

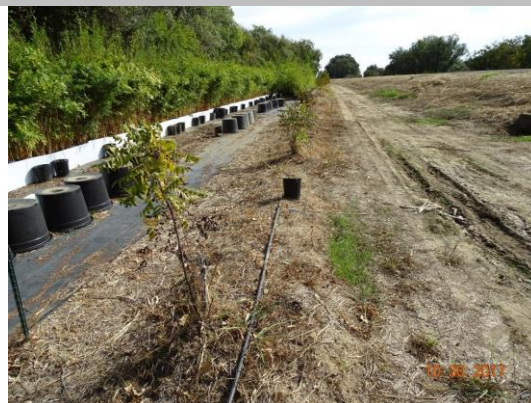
Photo 1 of 1 : SP_2019_ST0007_283_27_20190311_00005.jpg

View of small nut trees planted on waterside berm.

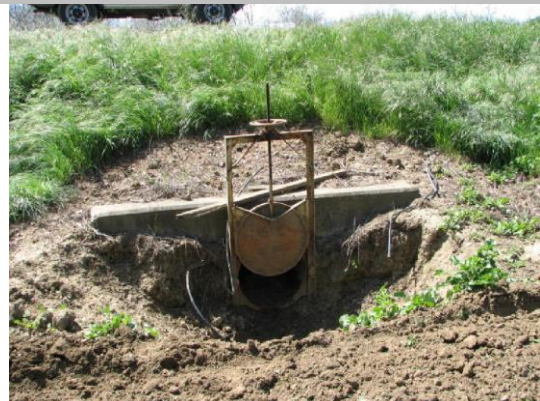
Photo 1 of 2 : UCIP_SP_2019_33346_60364.jpg

WS slide gate showing soil plug

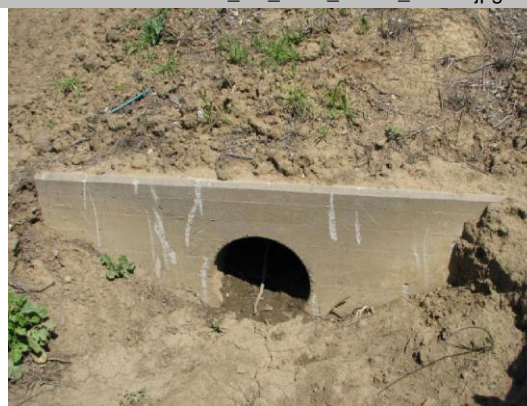
Photo 2 of 2 : UCIP_SP_2019_33346_60363.jpg

LS headwall showing soil plug

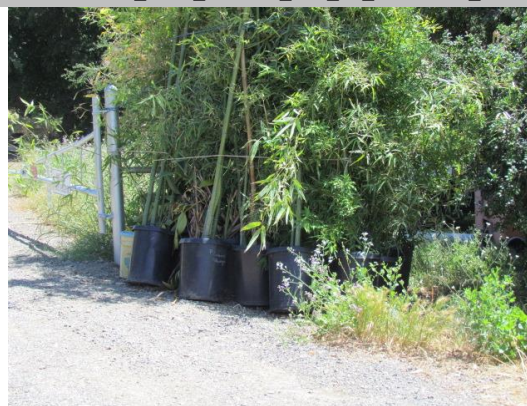
Photo 1 of 1 : SP_2019_ST0007_283_48_20190311_00020.jpg

Levee mile 6.70 at the District's gate landowner has placed several bamboo plantings against the gate way landward.
